Route Log and Progress Chart

DISTRICT	TOWN	ROUTE
6	WILLIAMSTOWN, BROOKFIELD, NORTHFIELD	I-89

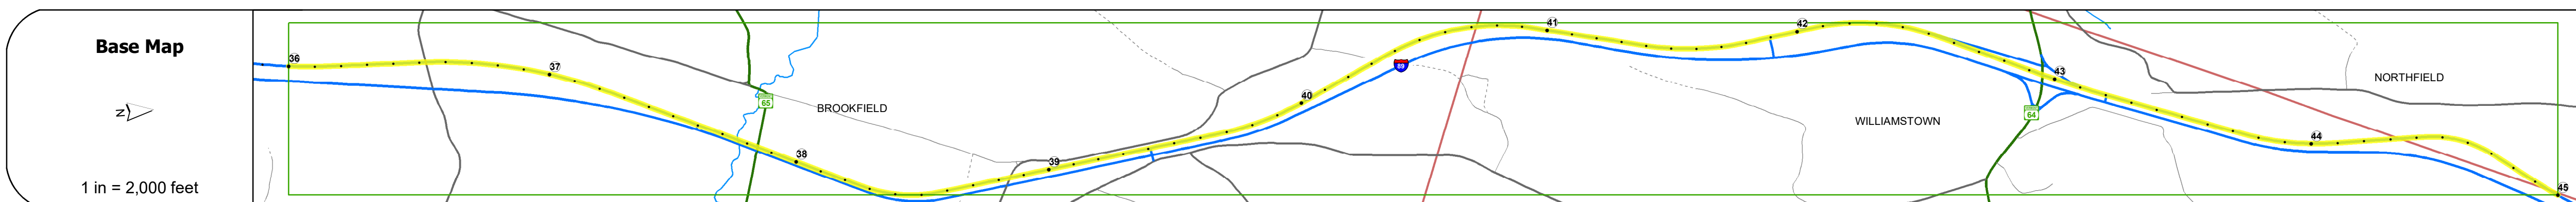
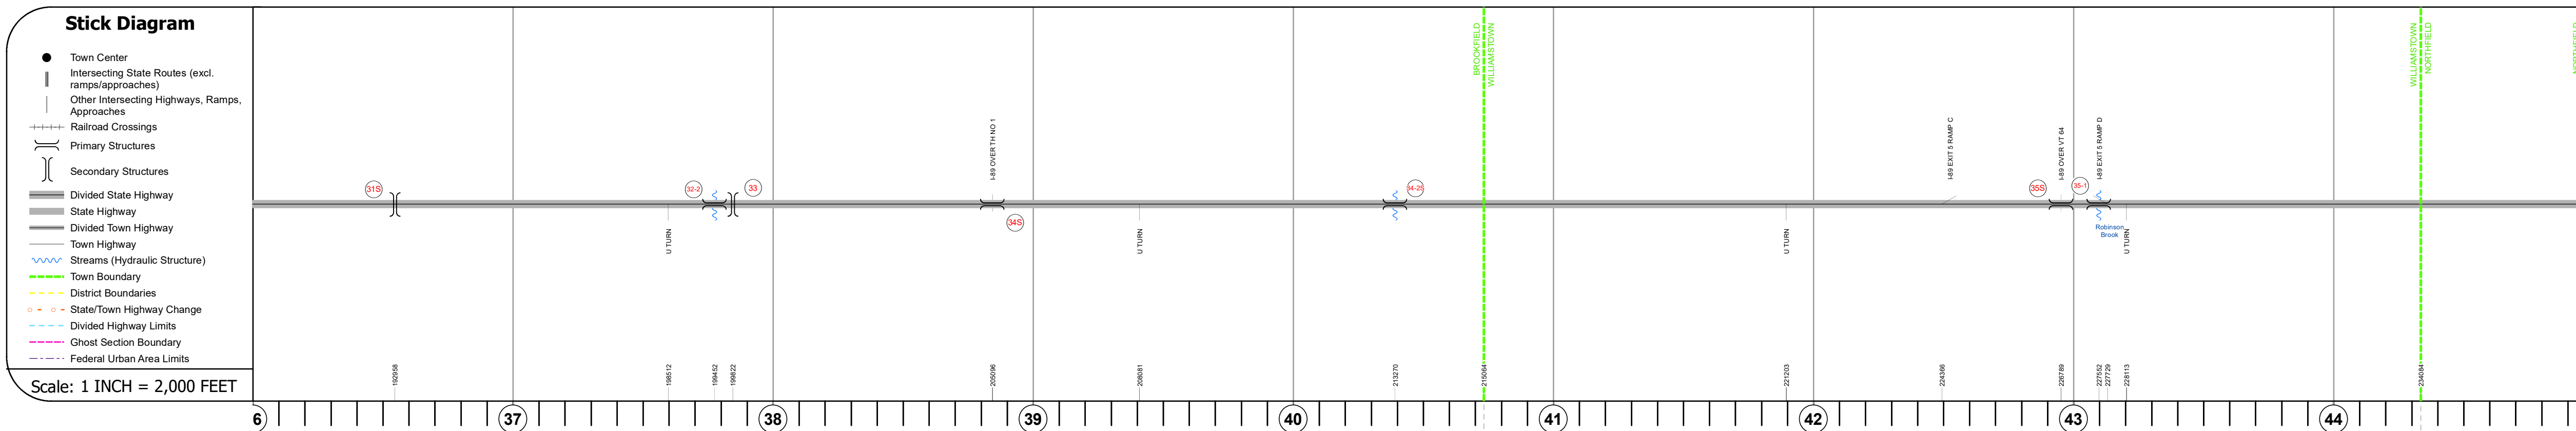
Travellane	
Roadway	
Lane Count	
Base	
Subbase	
Curves	
Grades	+4.2, +3.4, -5, +4.7, +3.6, +4, -4.6, -3, +3.9
Guardrails	
Rumblestrips	
Speed Zone	
Curves: Head-on, FTC6	
Curves: Overtun, FTC7	
Curves: Run-off Road, FTC8	
Curves: Fixed Object, FTC9	
Curves: Night Run-off Road, FTC10	
Interstate: Overtun, FTC11	
Tangents: Head-on, FTC12	
Tangents: Overtun, FTC13	
Tangents: Run-off Road, FTC14

Risk	Primary Risk (Red), High Risk (Orange), Medium Risk (Yellow), Low Risk (Light Green), Minimal Risk (Green), Not a Focus Facility (Grey)		
2022	8057	8681	8896
2021	7502	6499	8283
2020	6273	5756	7337
2019	8364	7675	9782
2018
